# Technical Service Bulletin

## 10 Oil loss from the filler cap

10 20 20 2059446/3 October 29, 2020. Supersedes Technical Service Bulletin Group 10 number 20-19 dated July 14, 2020 for reasons listed below.

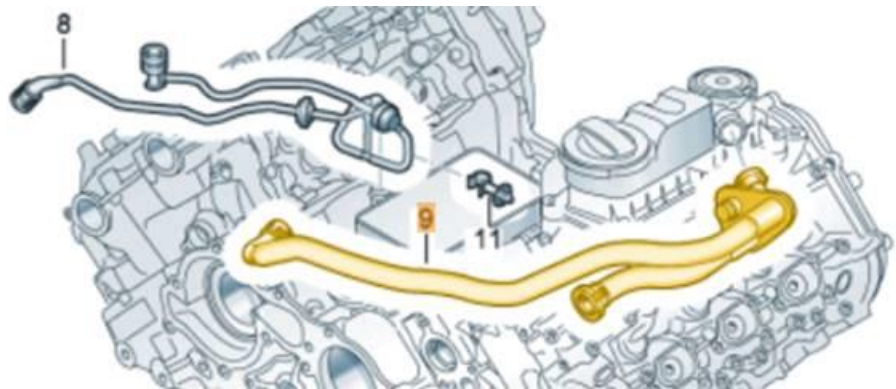
A faulty membrane in the breather line can result in excess pressure in the crankcase and therefore some oil loss through the filler cap.

**Figure 1.** Breather line for Turbocharged V6.

Replace the breather line (different variants available, only order by VIN) (Figures 1 and 2).

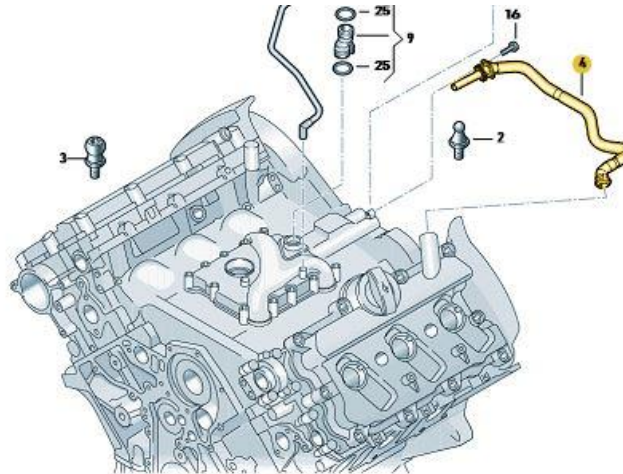
**Figure 2.** Breather line for Supercharged V6.
